# **LIBERTY STATE PARK TRAIN SHED HISTORIC PRESERVATION PLAN**

**2012 UPDATE TO 2001 INVESTIGATION AND REPORT  
MAY 1, 2012**

LIBERTY HISTORIC RAILWAY INC.

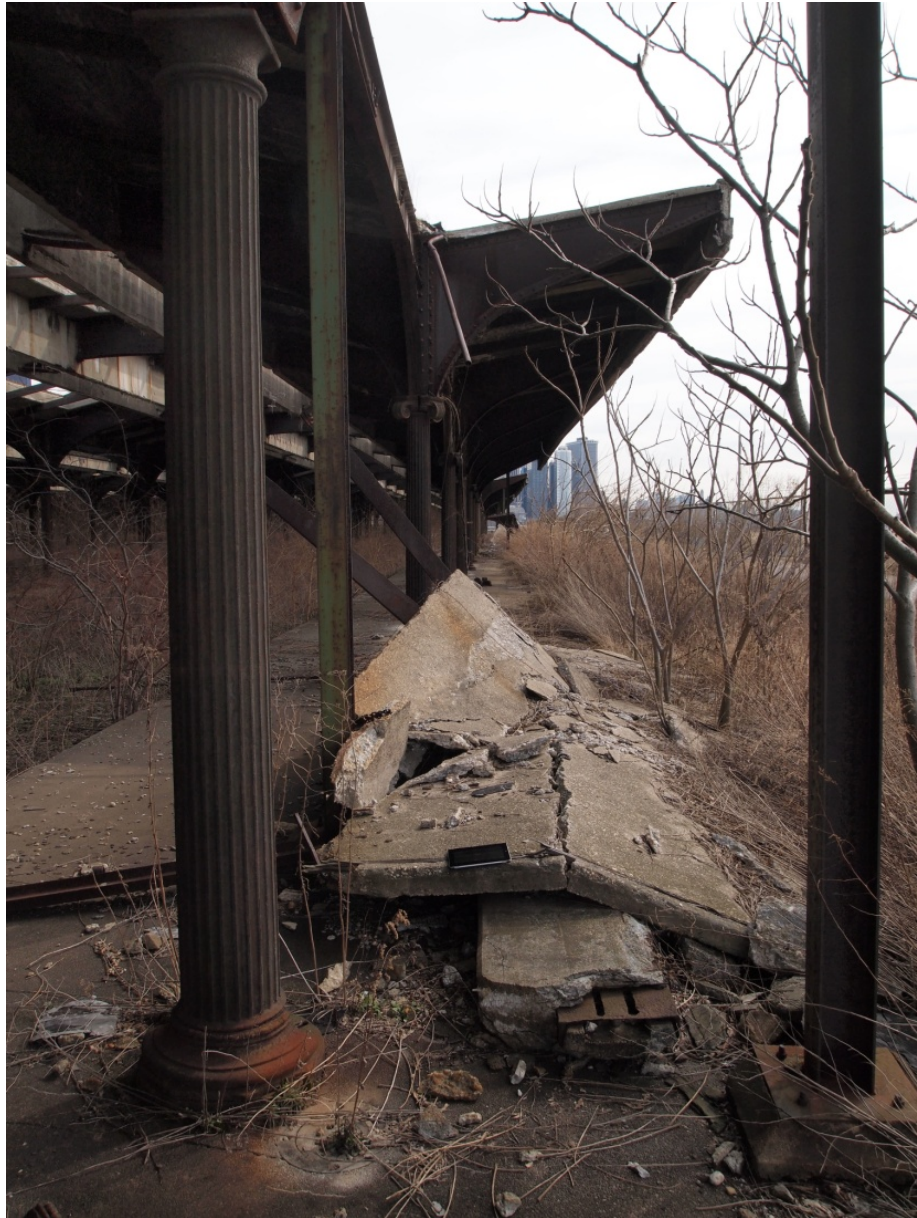
New collapse at  
column lines  
A/7-A/8, at the south  
edge of the train shed

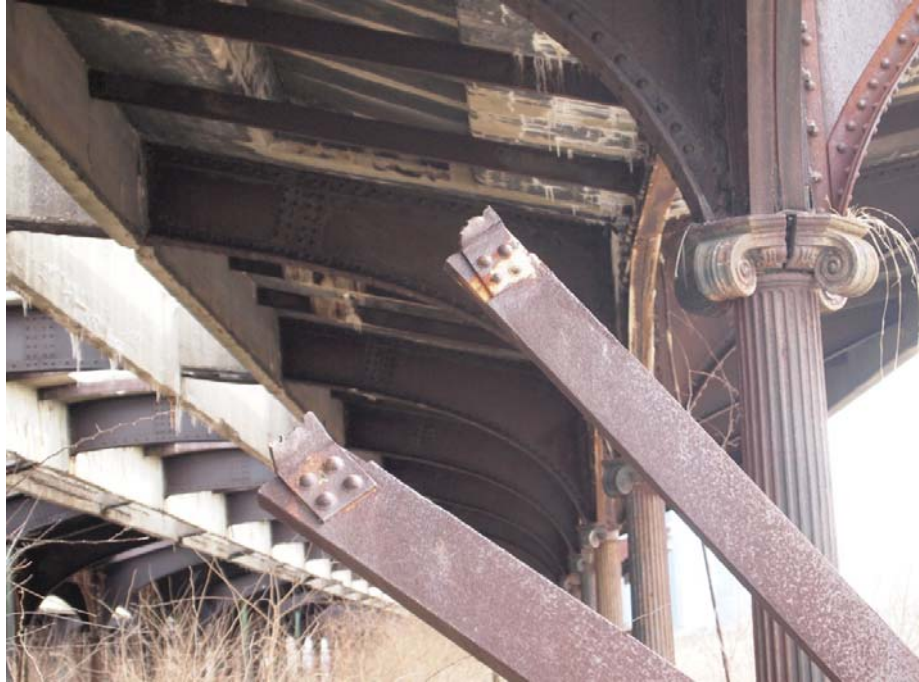
Failed roof beam  
connections at  
A/7-A/8

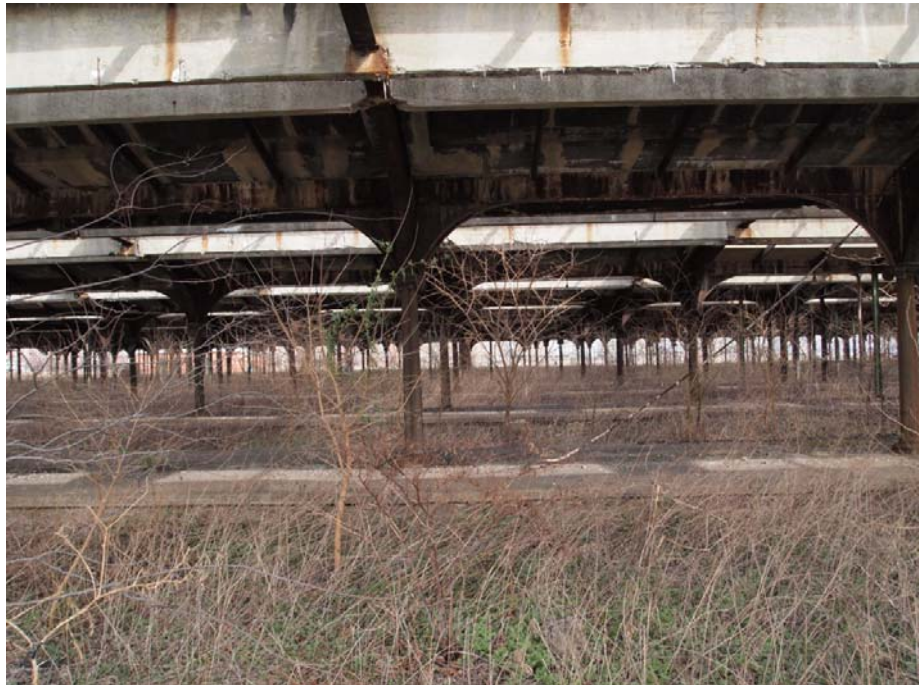
One condition that has become significant since the 2000 investigation is the presence of trees, vines, and other large plants growing within the shed. The plants are destructive to the structure in several ways, including root pressure on the concrete and lateral pressure where plants extend from below the roof through smoke vents or skylight openings to the open air above.

Vegetation growing  
within the train shed,  
from column line A  
looking north

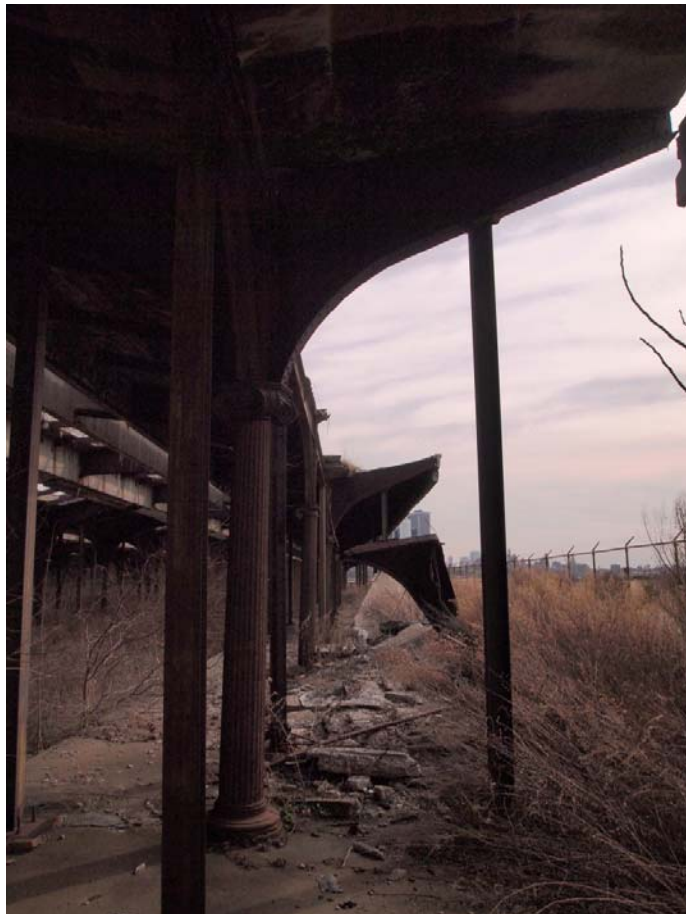
The main cantilever girder running from column A/14 to the south edge of the building has collapsed, apparently from failure of the connection at the square cast-iron top extension of the column. All of the other steel failures appear to have begun with failure of the connection of the edge beams to the cantilever girders.

Two-bay failure:  
failure from before  
2000 at column lines  
A/13-A/14  
(near the camera)  
And A/14-A/15  
(further from camera)  
Note collapsed  
cantilever girder from  
column line A/14

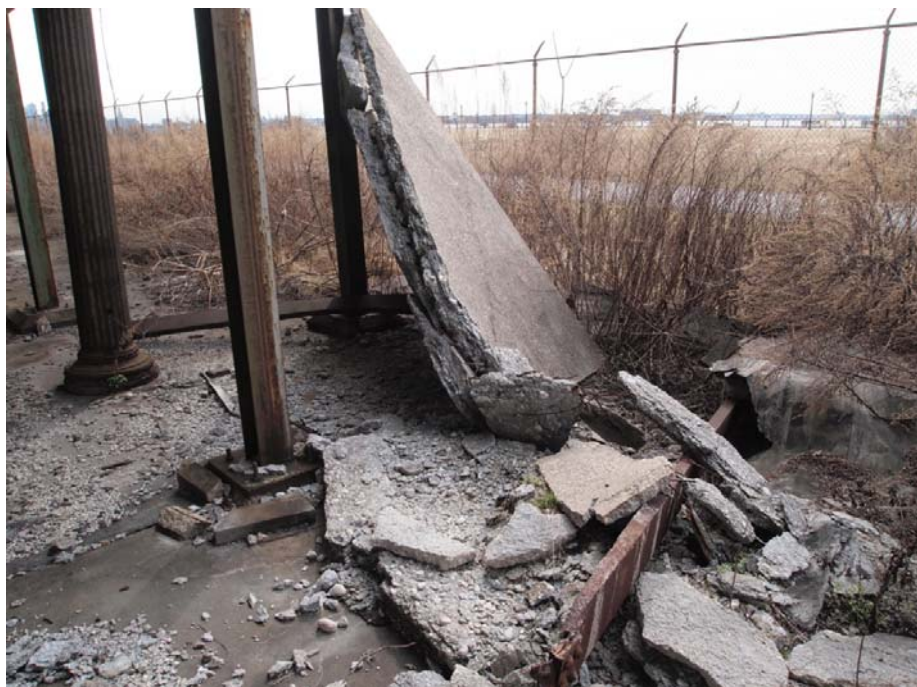
Concrete roof debris  
near A/15. Note the  
poor quality of the  
concrete at the broken  
edge and the spalled  
bottom.

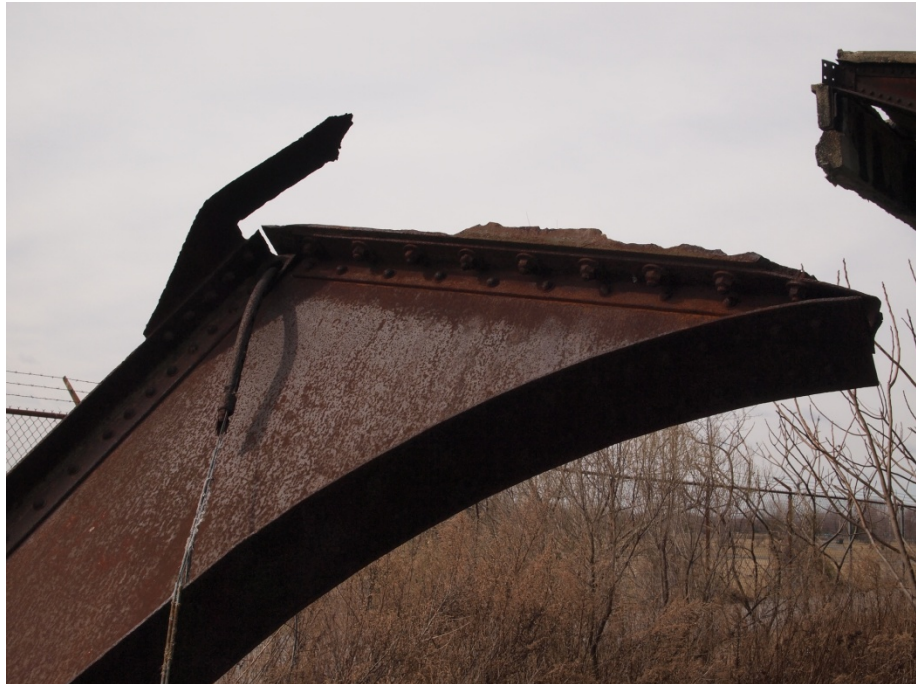
Failed connection of cantilever girder at A/14. Note that the steel girder connection angles, and bolts are intact; the broken edge of cast iron is visible

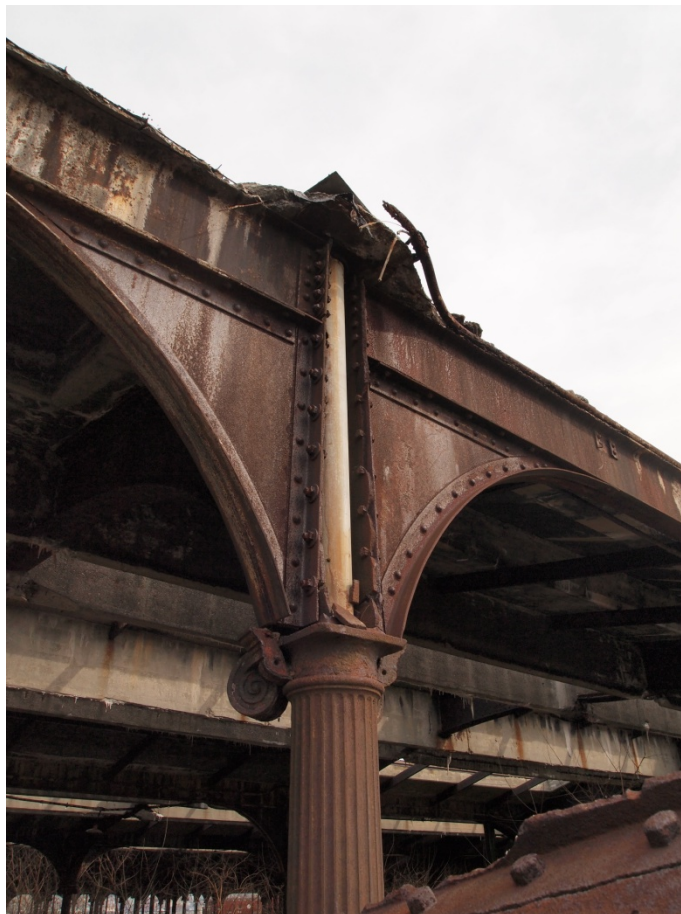
Former location of cantilever girder at A/14, showing remaining cast-iron column and top square-section connection extension, remaining A-line girders, and broken edges of cast iron

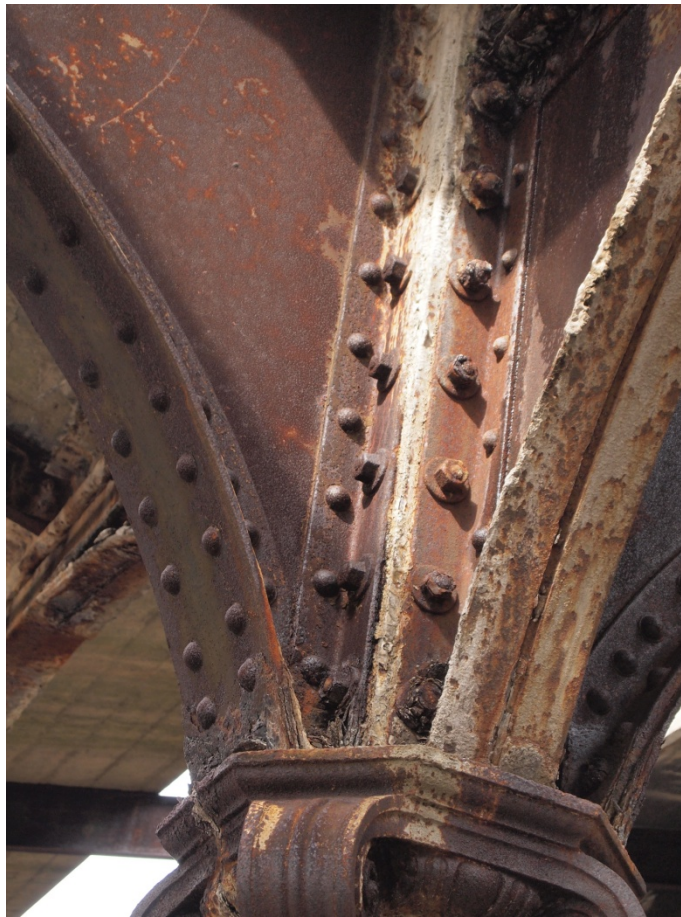
Rusting girders at  
column B/24

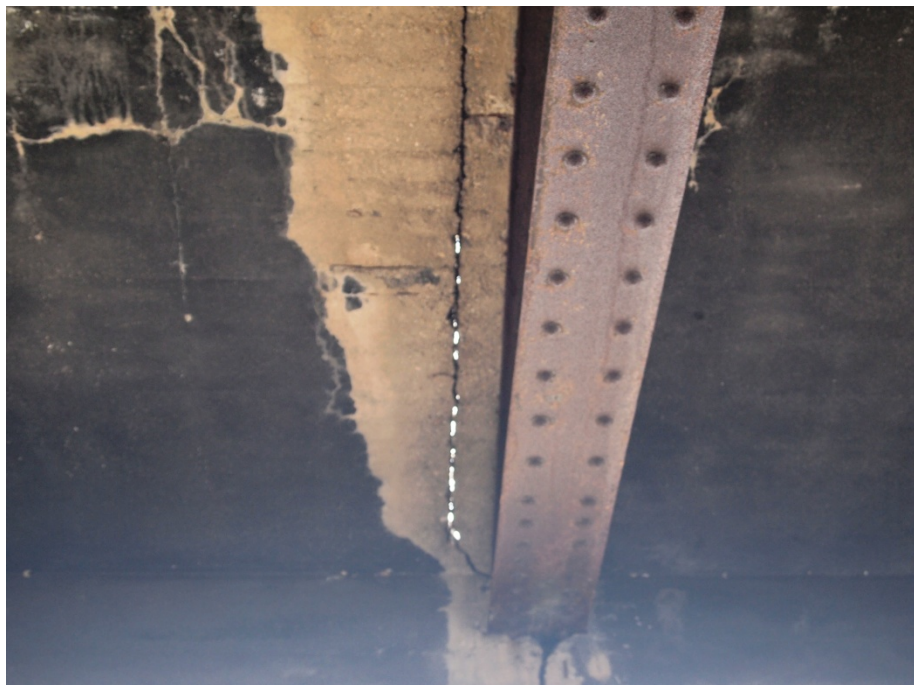
At one location, between K/27 and K/28, the concrete slab is cracked through and the slab in this bay is in imminent danger of failure even though the steel supporting it is in fair condition.

Concrete slab cracked  
through near K/28,  
imminent danger of  
slab collapse

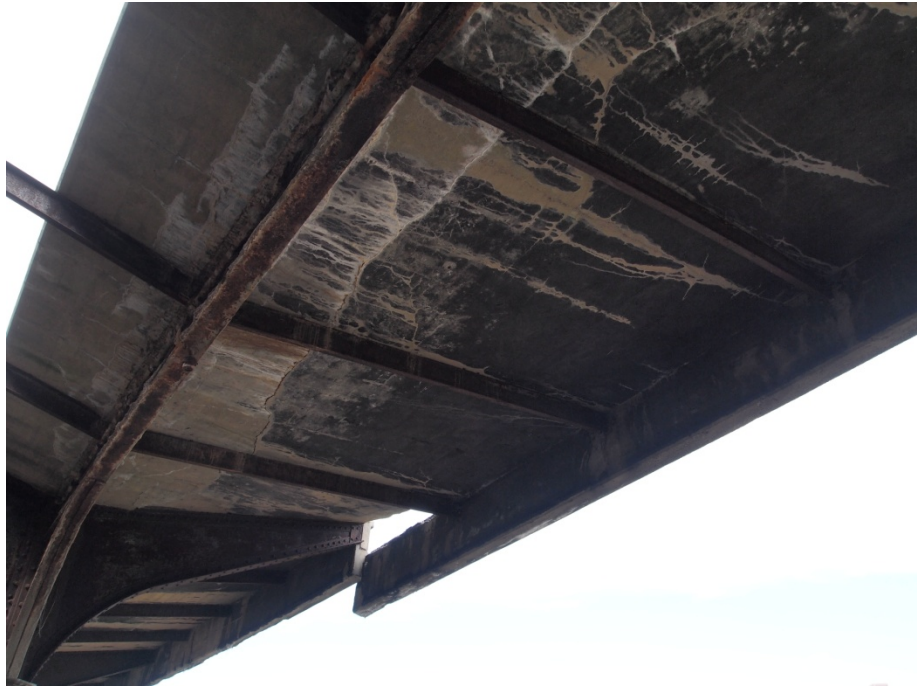
Most of the structure is stable against gross collapse, but the deterioration of the cantilevered-edge half bays has created several locations where the collapse of a section roof – similar to the collapses that have already taken place – could occur at any time. The edge half-bays at K/11-K/12 and ‘A/12-A/13 can collapse at any time.

Broken edge-girder to  
cantilever-girder  
connection near K/11.  
Edge bay is in  
imminent danger of  
collapse

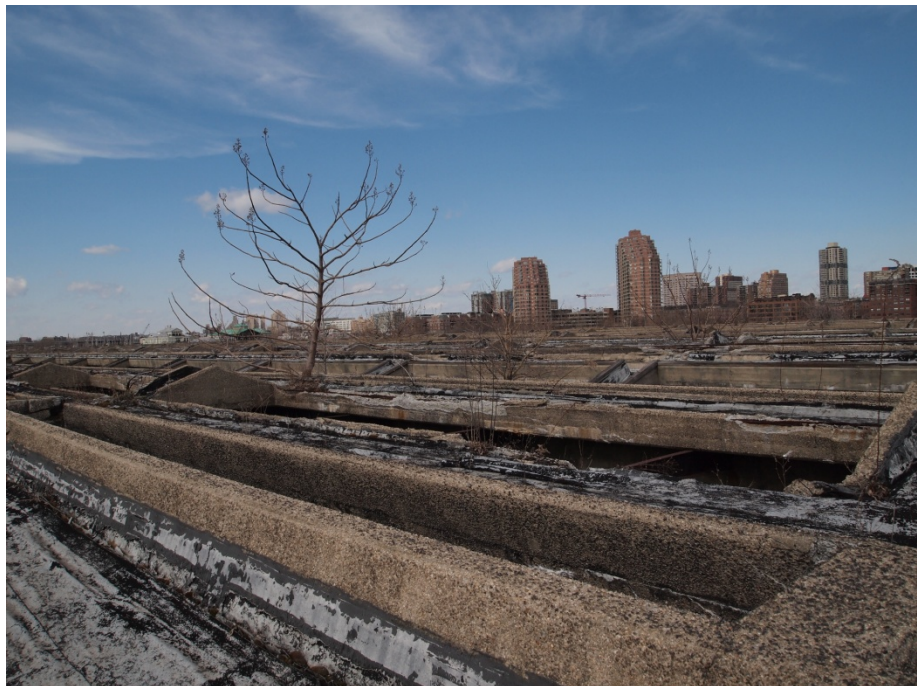
Plants growing on roof
