Trolley Lines

NJERHS GARNERS GRANT FOR THE PAINTING OF 2651.

Prepping Begins

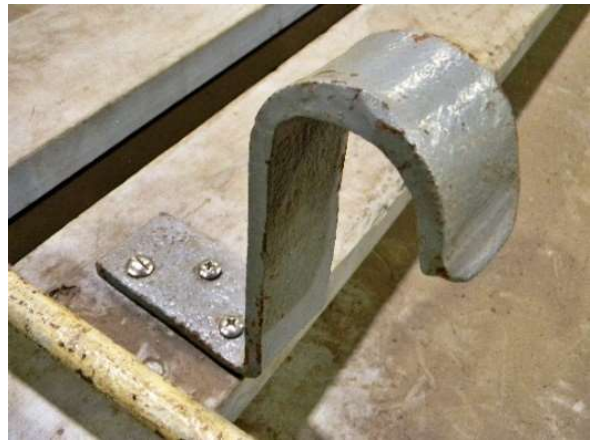
Re-installing both trolley pole hooks presented somewhat less of a problem.

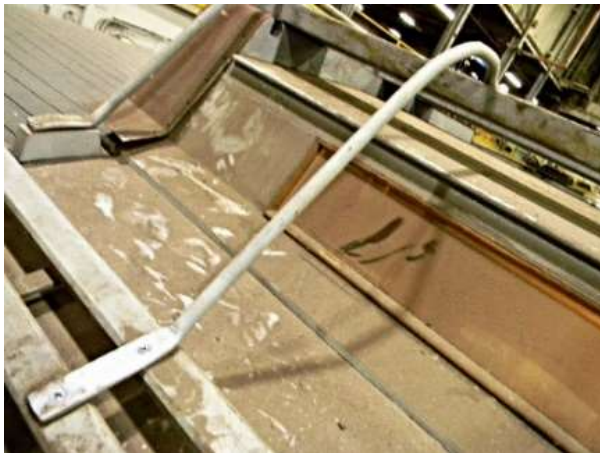
Also less difficult were the roof grab irons.

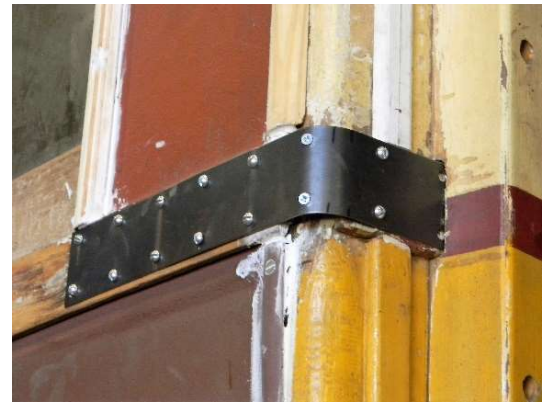
No, NOT the battleship NEW JERSEY, just one of four corner plates re-manufactured by our friends at Kinkisharyo LLC from a rusted out original and installed by Tony.

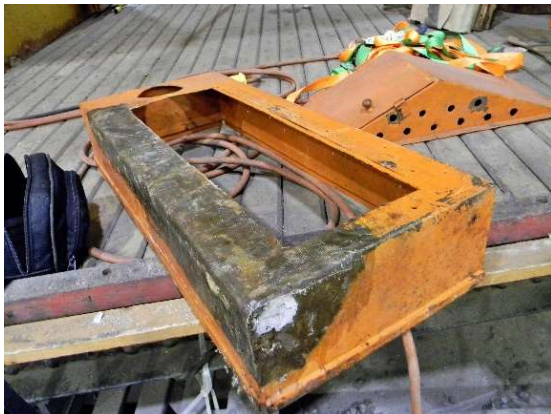
The destination sign box from the "B" end had suffered what many diagnosed as terminal rust-away. But, Doctor Bob Hooper to the rescue! Bob removed the dead "tissue" and skillfully regenerated new "flesh" using fiberglass and epoxy resin. Where do we find such people? We could use a few more, if you're out there!

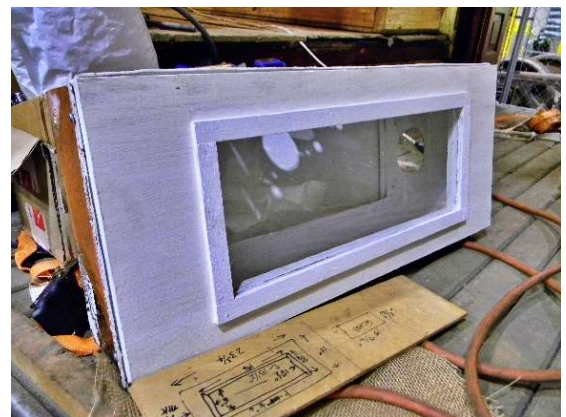
A new sign box cover was made up by Jim Houston, replicating the one at the "A" end, built by Tony at P-Burg years ago.
